*The Gisborne Cenotaph, erected on the Turanganui River bank in 1923, suffered significant structural damage during a 6.8 magnitude earthquake in December 2007. The earthquake left this nationally significant monument at risk of serious damage in future seismic events.*

**Project:**  
Gisborne Cenotaph Repair

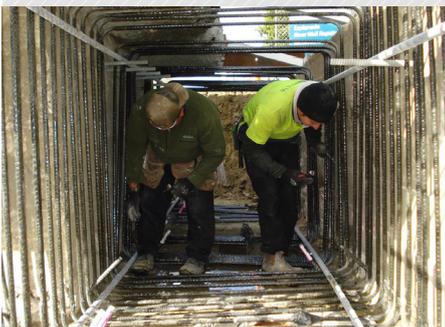
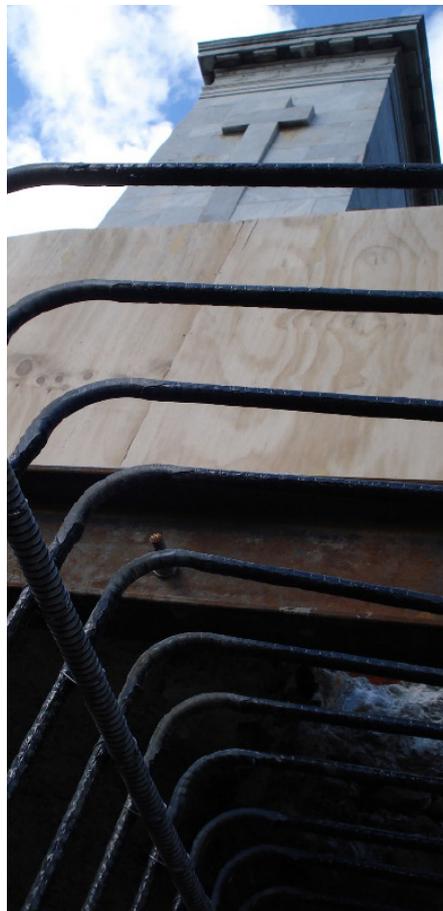
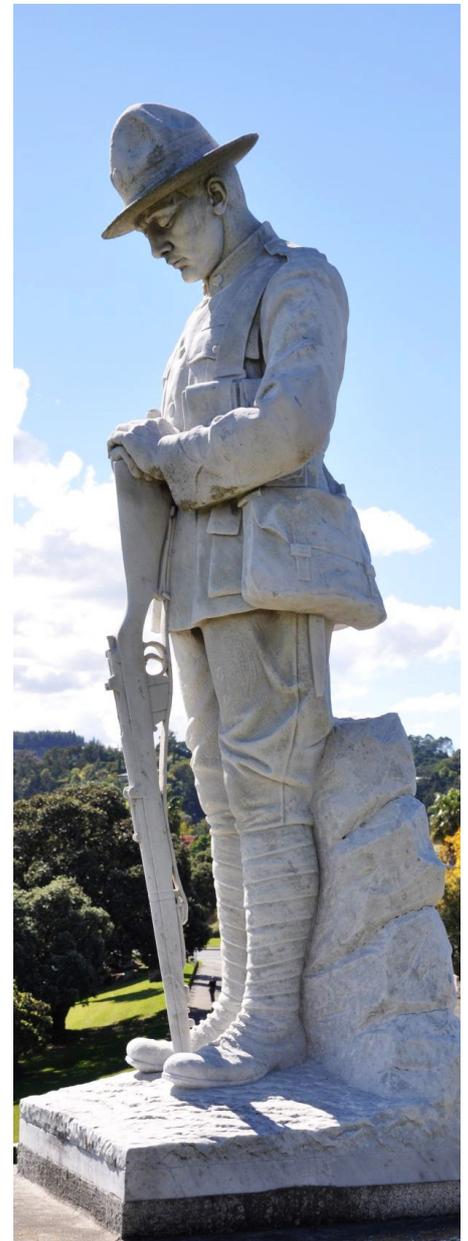
Major strengthening of the foundations, were necessary to protect the Cenotaph. These works included the removal of soil surrounding the foundations, demolishing portions of the original foundation and casting a substantial foundation ring beam around the central core of the Cenotaph. This new foundation was supported directly on screw piles and designed to support the entire Cenotaph structure.

The consultants ensured the repairs were undertaken to give longevity and minimize any need for future repairs. A significant feature of the remedial work, was to ensure that the Cenotaph was not damaged through long term corrosion of any reinforcing present. As a result, **mateenbar™** was specified for the stirrups and longitudinal steel reinforcing the foundations. Unlike steel, **mateenbar** doesn't need any extra form of protection, as it doesn't corrode – an important feature considering the salinity of the Cenotaph's coastal location.
